## HIGH SPEED CENTRIFUGE INCIDENT

In April 2009, a catastrophic rotor failure occurred at a University location with a Sorvall Discovery 90 centrifuge. The failure emphasizes the importance of exercising extraordinary caution in the use of such equipment. Although the centrifuge utilized a Surespin 630 Rotor, a swinging-bucket rotor, **user caution should be directed towards all high-speed centrifuges, regardless of brand**, particularly when swinging buckets are used.

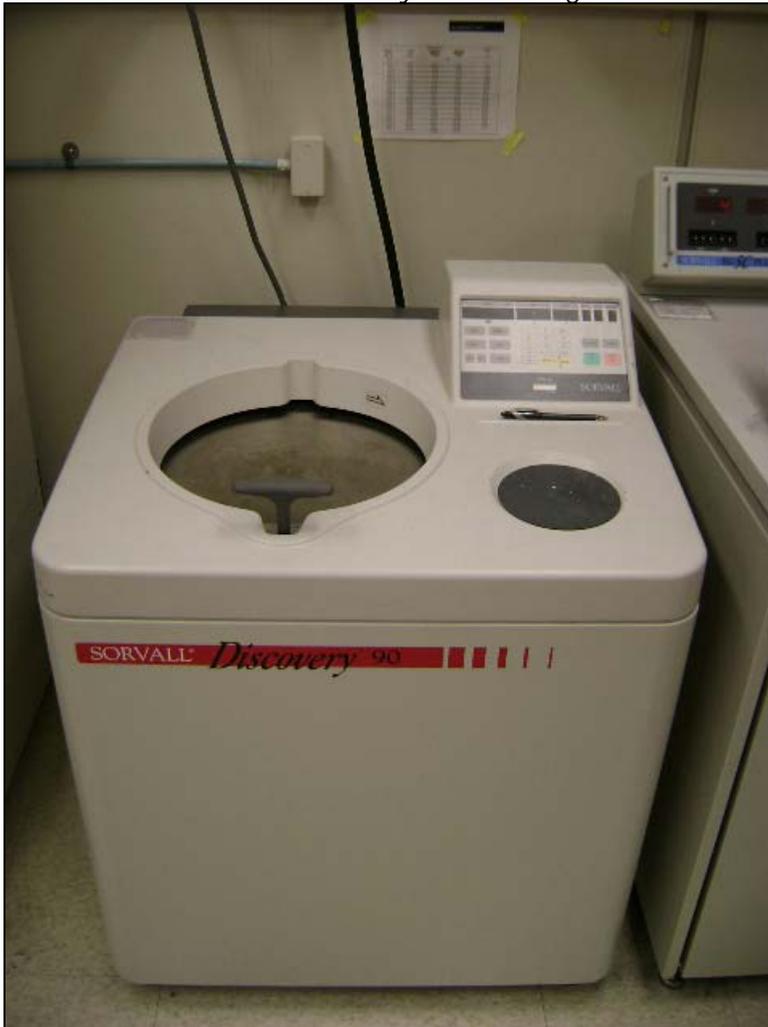
Sorvall Discovery 90 Centrifuge

The incident occurred immediately after the principal investigator had instructed a graduate student in a protocol where DNA extraction utilizing cesium chloride was to occur. The lab's established protocol required two people to be present, where one individual witnessed each step of the protocol the other researcher was following. Once all the preparation work was completed and each tube's weight was verified to be the same, the tubes were seated in the bucket of the rotor, the centrifuge door was closed, the speed and time were programmed into the centrifuge, and the cycle begun. Since this rotor was rated at 30,000 rpm, the estimated time for the spin was determined to be 72 hours. After a few minutes of operation the unit got to the established speed. Approximately 8 minutes later, the rotor failed.

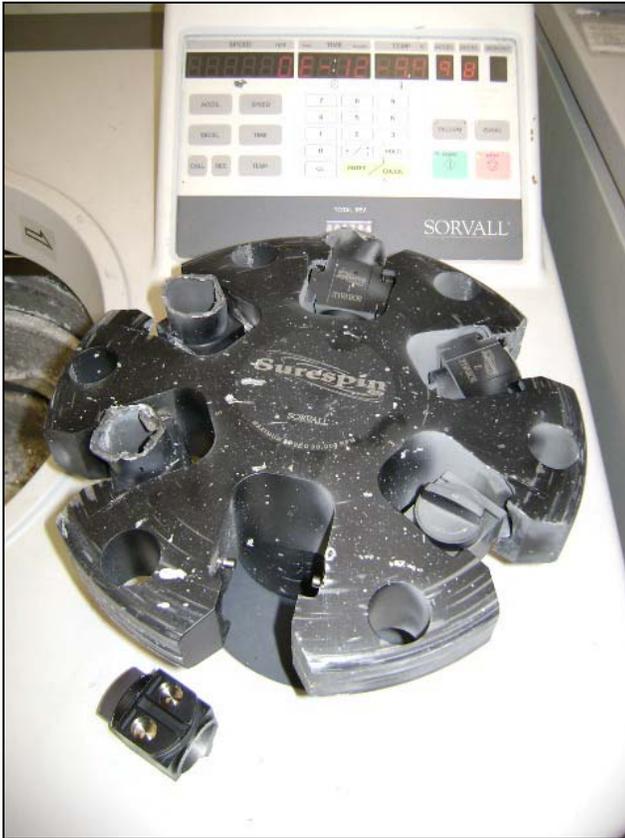
Damaged Surespin 630 Rotor

- Never exceed the maximum rated speed of the installed rotor; to do so can cause rotor failure.
- Always reduce (derate) rotor speed whenever:
  - The load exceeds the maximum allowable compartment mass (the average fluid density is greater than 1.2 g/ml). See chapter 2, Operation.
- When compartment loads exceed design mass, the maximum rotor speed must be reduced using one of the formulas provided. Failure to do so can result in rotor failure.
- This method is not appropriate for calculating reduced speeds when running gradient materials that could precipitate, such as cesium chloride. Precipitation of crystallized cesium chloride produces stresses far in excess of the design limits of the bottom of the rotor buckets.

For the procedure resulting in the rotor failure, 0.98 g/ml of cesium chloride was used. The MSDS for cesium chloride states that the chemical has a density of 3.99 g/ml. Inserting this information into the equation gives:

$$\text{Reduced Speed} = 30,000 \times \sqrt{\frac{1.2}{3.99}} = 16,500 \text{ rpm.}$$

Note: manufacturers also recommend that rotors be derated by about 10% after the rotors are used for 1000 runs. Had this rotor been used extensively, the maximum allowable speed would have been even less (in this case, 14,850 rpm).

Many manufacturers can provide researchers with special programs to determine the maximum speed for a rotor. In a University setting, it is especially important to make sure newer personnel understand the hazards of the equipment and materials being used. In addition to the hazard recognition and training of personnel for the safe operation of rotors in centrifuges, EH&S recommends a warning be placed in a prominent location on their centrifuge stating:

Fixed angle rotors are recommended for dense gradients because the stresses of cesium chloride gradient and possible precipitation is distributed along the centrifugal wall (a larger area) of the tube cavity instead of the bottom of the bucket (a small area) of the swinging bucket rotor.

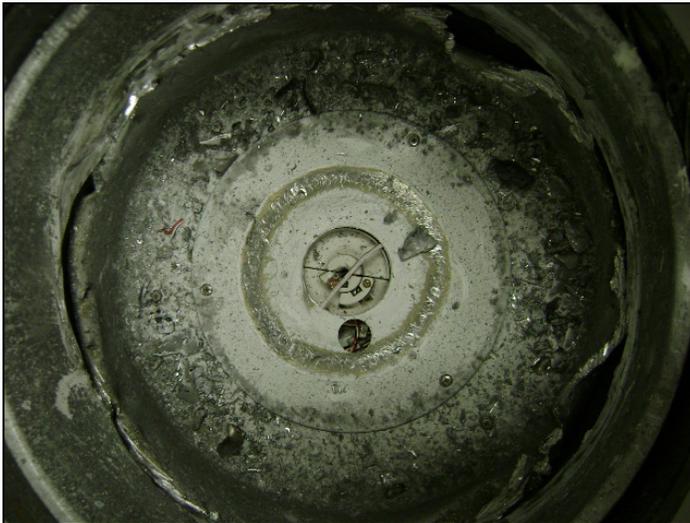
Basket of Centrifuge

**Fortunately, this centrifuge's door was designed to contain the tubes, bucket and rotor in the event of a catastrophic failure. The unit operated as designed and contained these materials inside the unit. Fortunately, no one was injured.**

Although all high-speed centrifuges are heavily armored for protection from horizontally propelled rotor pieces, some have covers that can resist only minimal vertical forces and could fly open, permitting violent escape of rotor parts or liquids. No one should have a workstation adjacent to the centrifuge; there should be an exclusion area of 15 feet or more in radius. (Some of the missiles from the failed centrifuge bounced and ricocheted even further than this.)
